Manhole Inspection Summary

Manhole # S29Q__014MH

Insp Date: 11/5/08 1:07 PM

Location Address: **1267 Scott St**

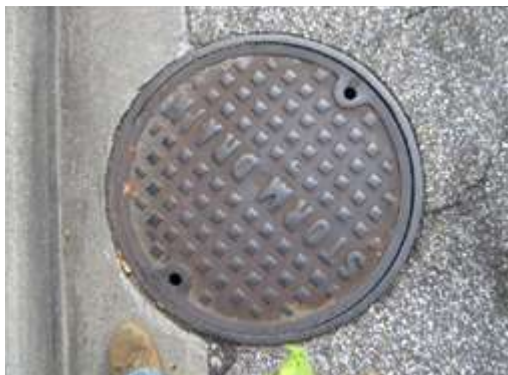
Miscellaneous

mh cover

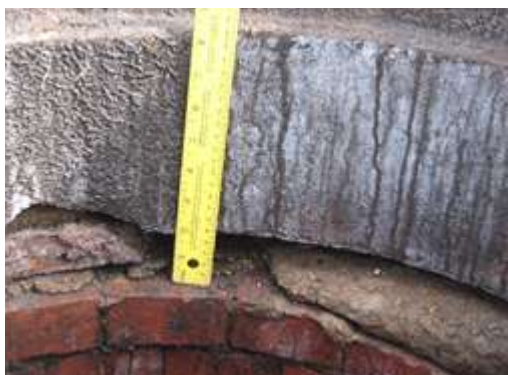
Defect 5

Condition: ☐ Sound ☐ Cracked ☐ Root Intrusion ☒ **Loose Brick** ☒ **Deteriorated**

Infiltration: ☐ None ☒ **Joint** ☐ Cracks ☐ Mortar ☐ Roots ☐ Wall

chimney deteriorated with loose brick & infiltration from joint

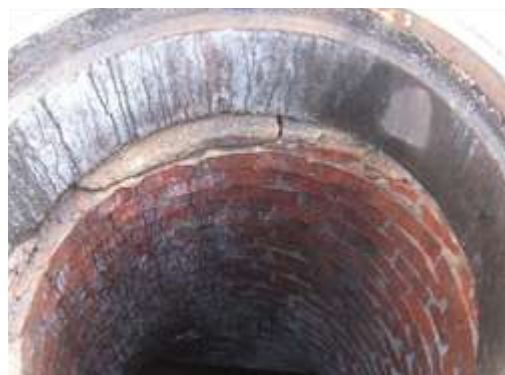
Defect 3

Frame Offset: **2** (in.) Condition: ☐ Sound ☐ Cracked ☒ **Leaks**

frame leaks & is offset

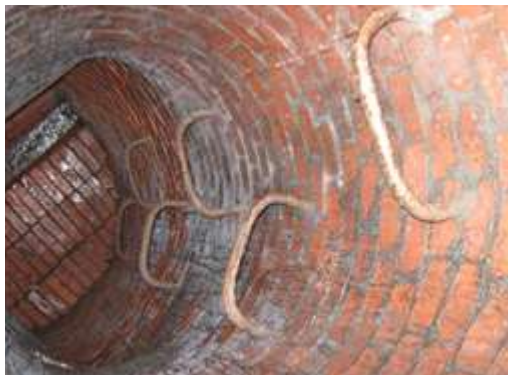
Defect 1

Steps Count: **5** Missing: **0** ☒ **Corroded**

corroded rungs

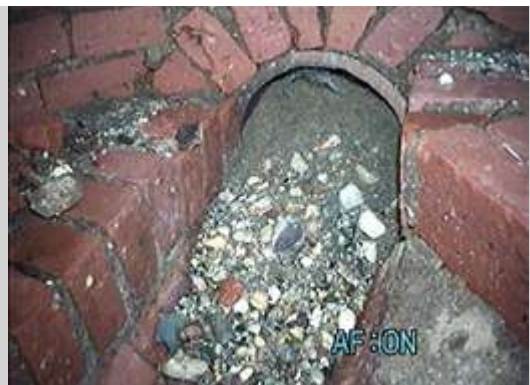
6 O'Clock Inflow

Deposits: ☐ None ☐ Mud ☐ Sludge ☒ **Debris** ☐ Grease

Silt Depth: **0** (in.) Deposits Extent: **Heavy**
